# Manhole Inspection Summary

Manhole # S55K\_\_029MH

Insp Date: **5/29/08 11:37 AM**

**Location** Address: **3602 fait**

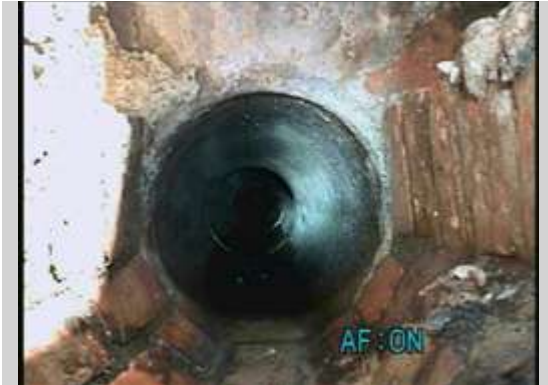
12 O'Clock Outflow

8 in. Circular Gravity Sewer  
Pipe Out @ 12 O'Clock

Pipe Material: **Clay** ☐ Pipe Lined

Invert Depth: **5.70** (ft.) Flow Characteristics: **Slow**

Deposits: ☒ None ☐ Mud ☐ Sludge ☐ Debris ☐ Grease

Infiltration: **None** Pipe Seal Cond: **Unknown**

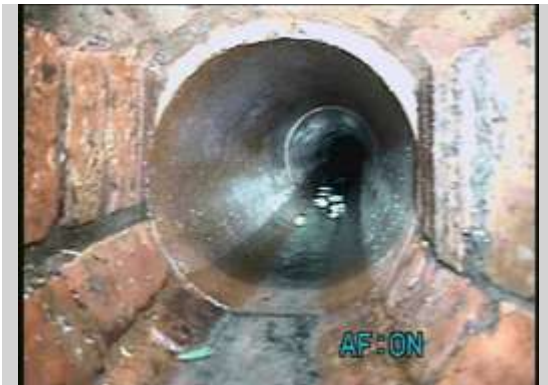
9 O'Clock Inflow

8 in. Circular Gravity Sewer  
Pipe In @ 9 O'Clock

Pipe Material: **Clay** ☐ Pipe Lined

Invert Depth: **5.50** (ft.) Flow Characteristics: **Slow**

Deposits: ☒ None ☐ Mud ☐ Sludge ☐ Debris ☐ Grease

Infiltration: **None** Pipe Seal Cond: **Unknown**
